Subject: 2022 Annual Report
Inactive Portion of Former ARCO Chemical Company
East Landfill Area, Monaca, PA
CEC Project 142-329

2022 ANNUAL REPORT

LE PETOMANE EAST LANDFILL AREA
MONACA, PA

September 2021 Inspection and Maintenance Survey
Le Petomane East Landfill Area
CEC Project 142-329

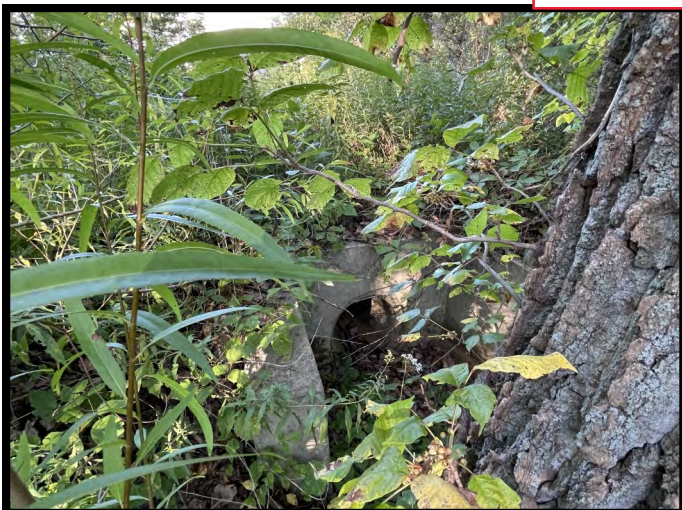
Culvert EL-1 and aEL-2
as controls look blocked

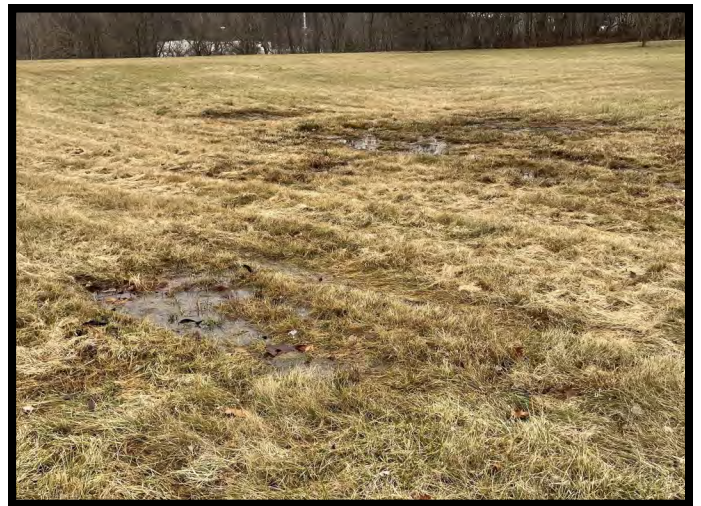
Pooling Water near Latex and Phosphate Area

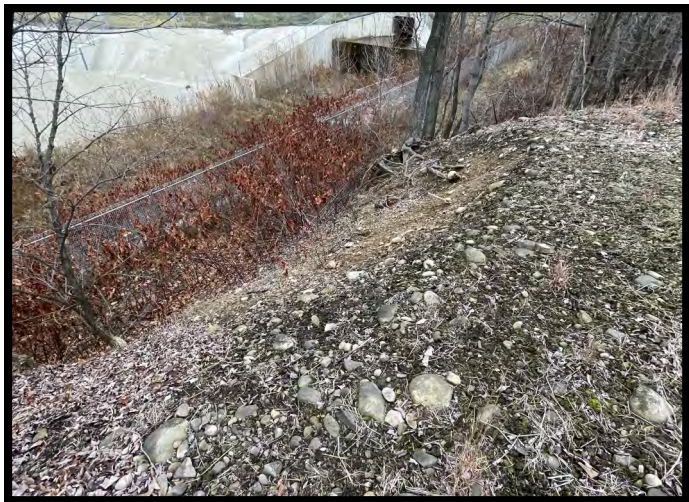
Minor Erosion Near EL-7

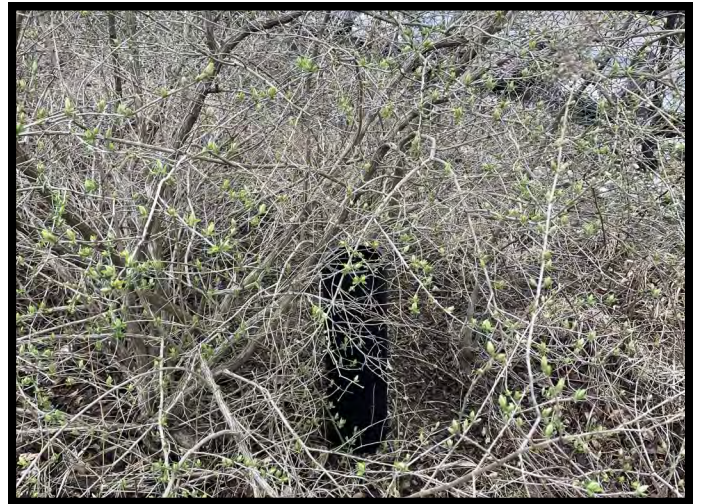
Pipe Near BASF Property

Where does
culvert
discharge?
What is the
orange liquid
observed in
March 2022
inspection?
